Ruins Stabilization in the Southwestern United States

RUINS STABILIZATION IN THE SOUTHWESTERN UNITED STATES

**ROLAND VON S. RICHERT and
R. GORDON VIVIAN**

National Park Service
U. S. Department of the Interior
Washington 1974

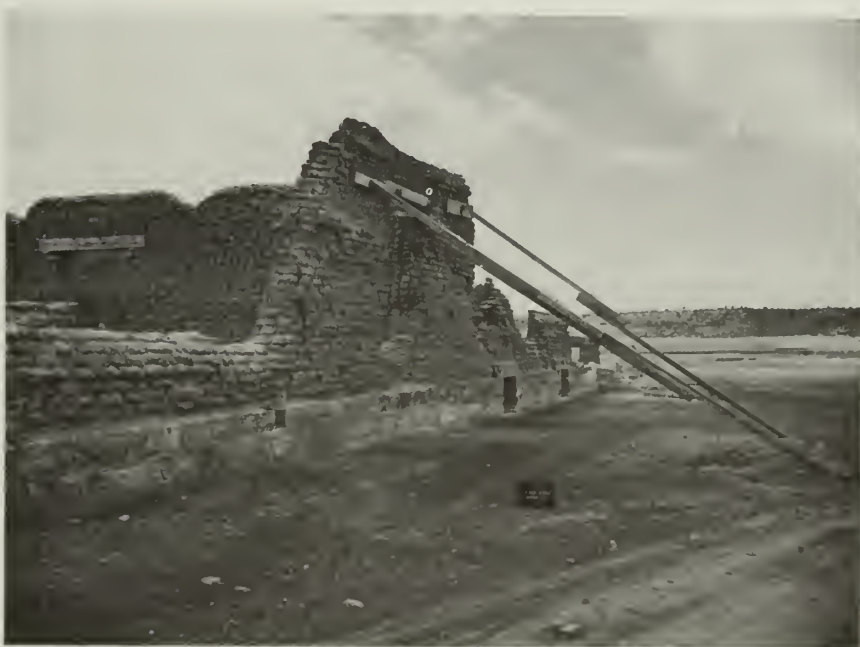
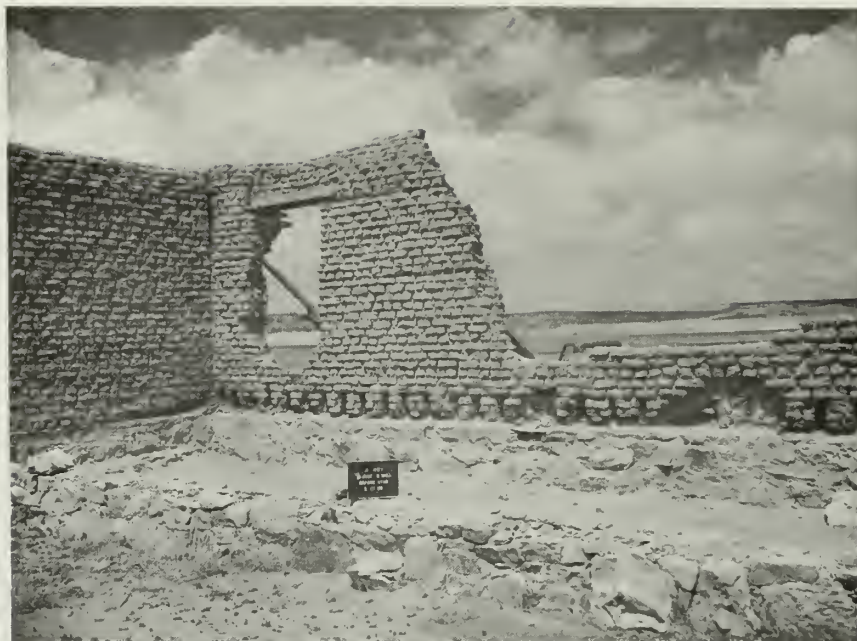
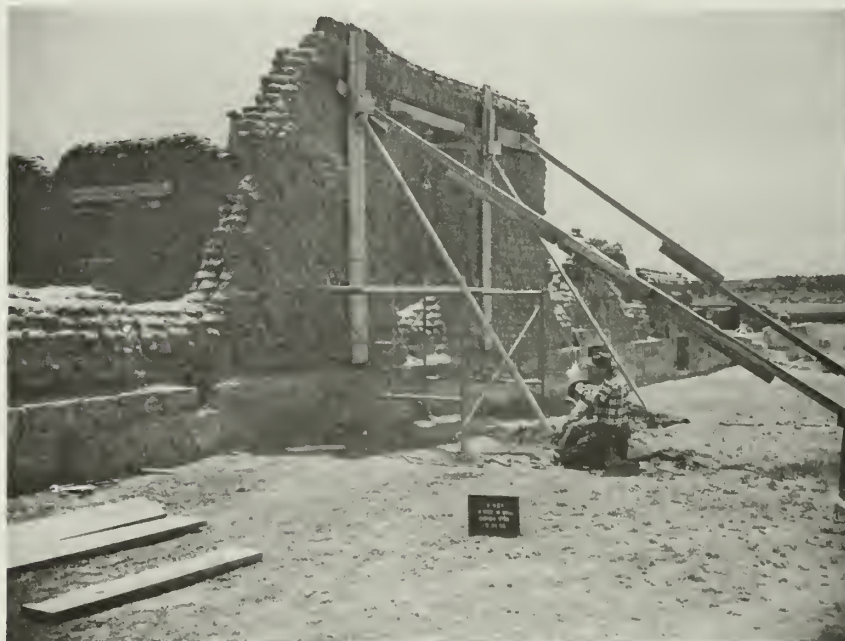
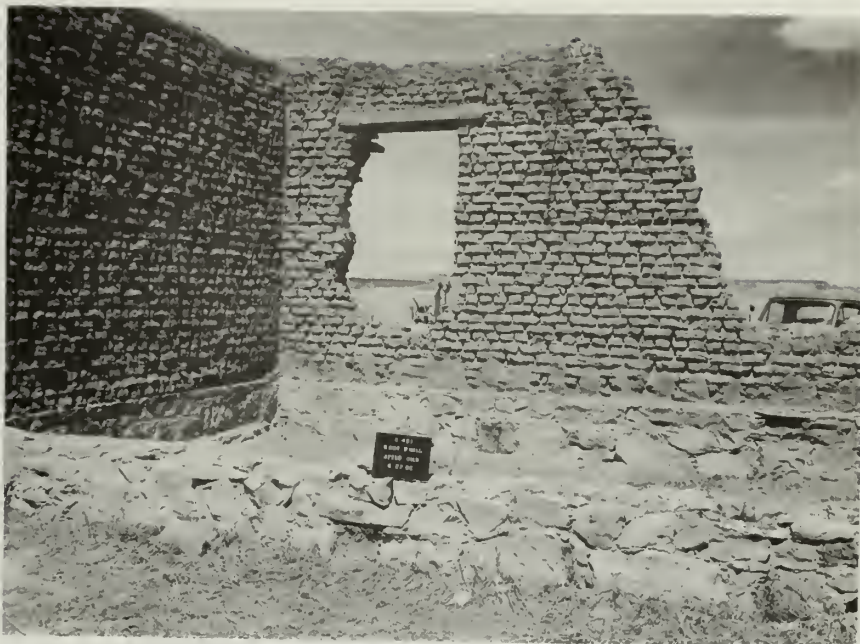
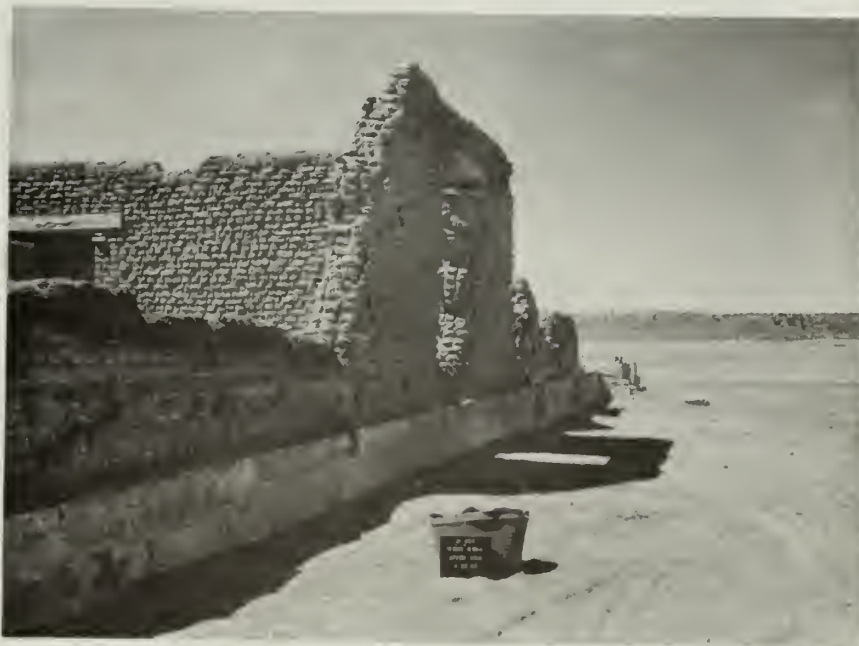
FIGURE 88. Building 3-450, Room 451, north side of north wall, before stabilization. Fort Union National Monument.

FIGURE 89. Building 3-450, Room 451, south side of north wall, before stabilization. Fort Union National Monument.

FIGURE 90. Building 3-450, Room 451, south side of north wall, during stabilization. Fort Union National Monument.

FIGURE 91. Building 3-450, Room 451, south side of north wall, after stabilization. Fort Union National Monument.

FIGURE 92. Building 3-450, Room 451, north side of north wall, after stabilization. Fort Union National Monument.

North wall: Two deadmen holes, 2' x 4' x 22", were dug next to the joist footing wall inside the room. Two 44" lengths of 1/2" reinforcing rods

were welded perpendicular to 2' lengths of 2" x 2" angle-iron, and looped at the other ends. These were placed in the holes which were then filled with concrete, reinforced with heavy wire. The wall was then jacked into plumb with mine jacks. A 15' length of 1 1/2" x 1 1/2" angle-iron was placed horizontally against the outside of the wall, near the top just above the lintel. The angle-iron was held in place by long bolts made by welding 5/8" carriage bolts on one end of 44" lengths of 1/2" reinforcing rod; these same rods were looped on the other ends to accommodate the 4" steel cable that was then attached to the deadmen. Turnbuckles on the two 16' cables allow for tightening.

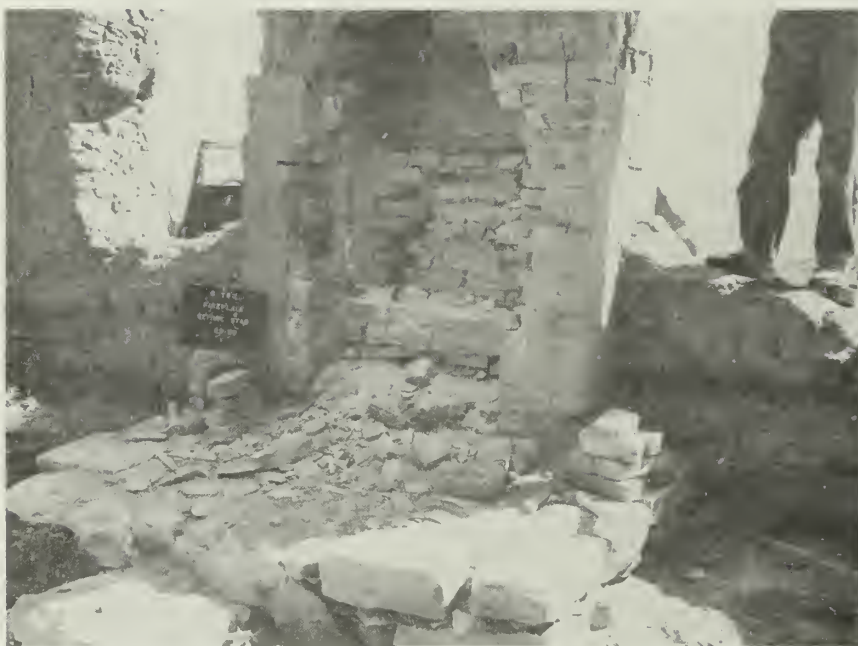
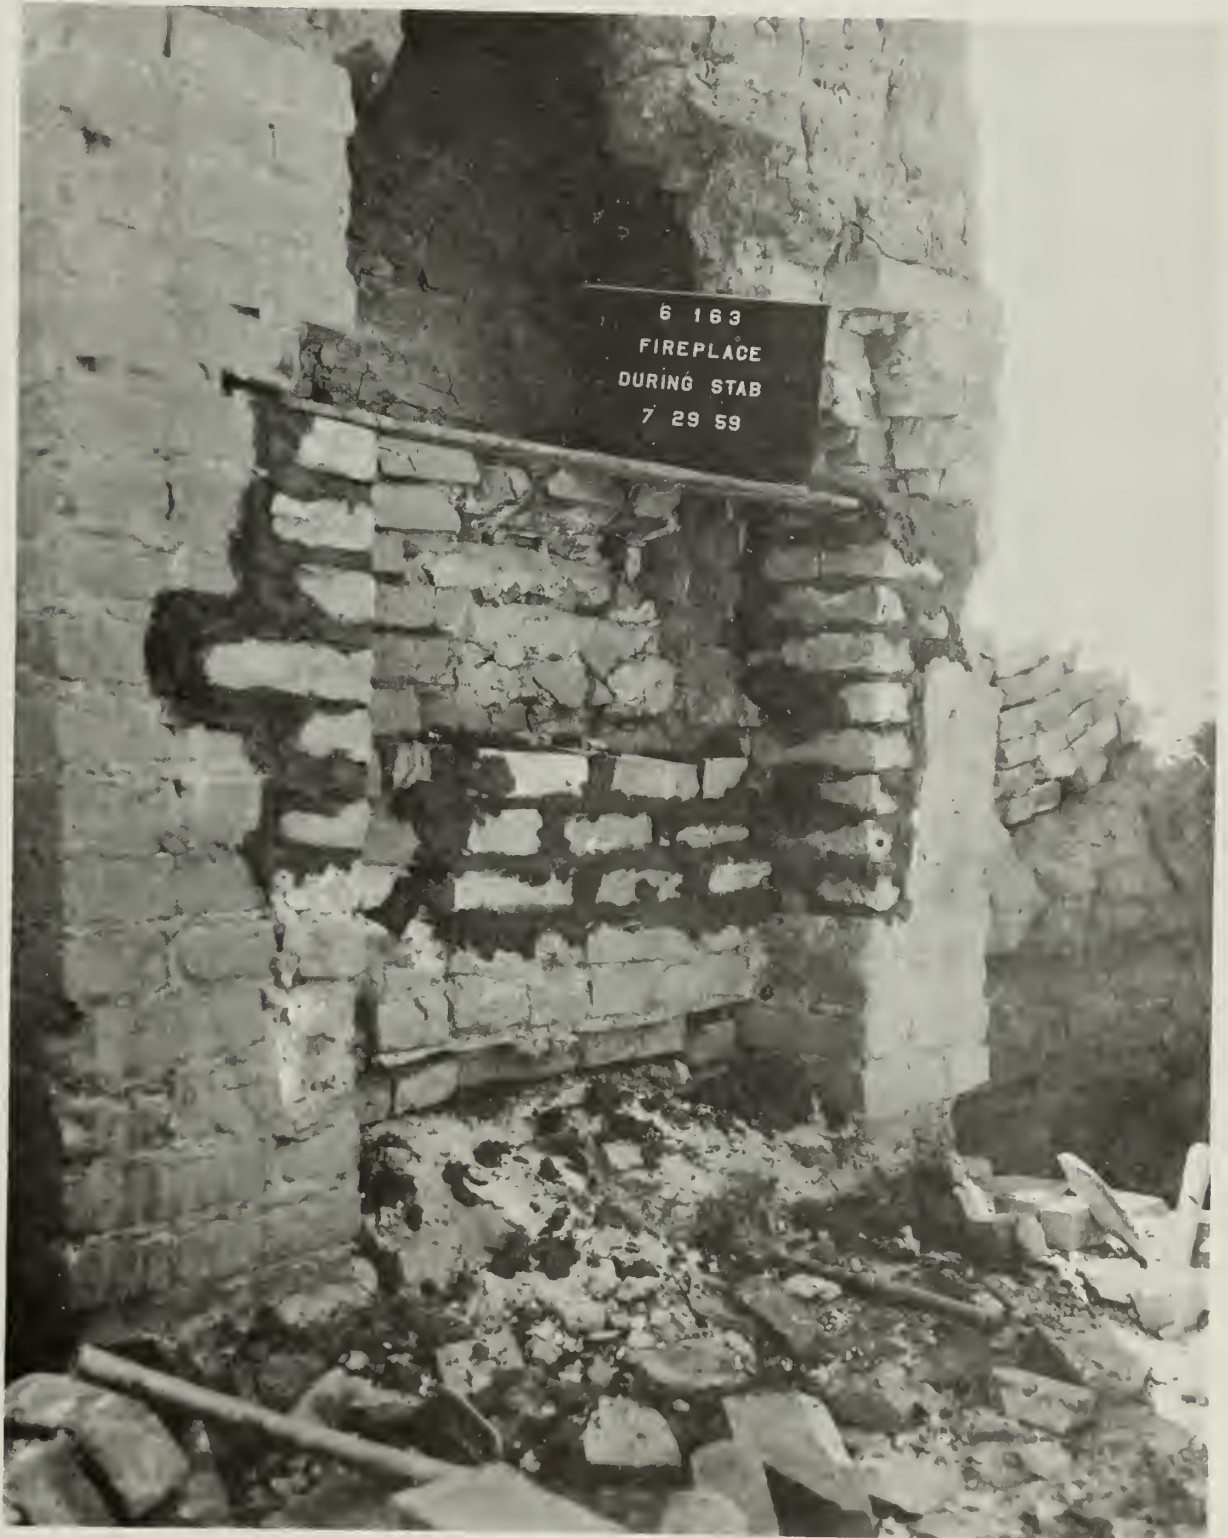
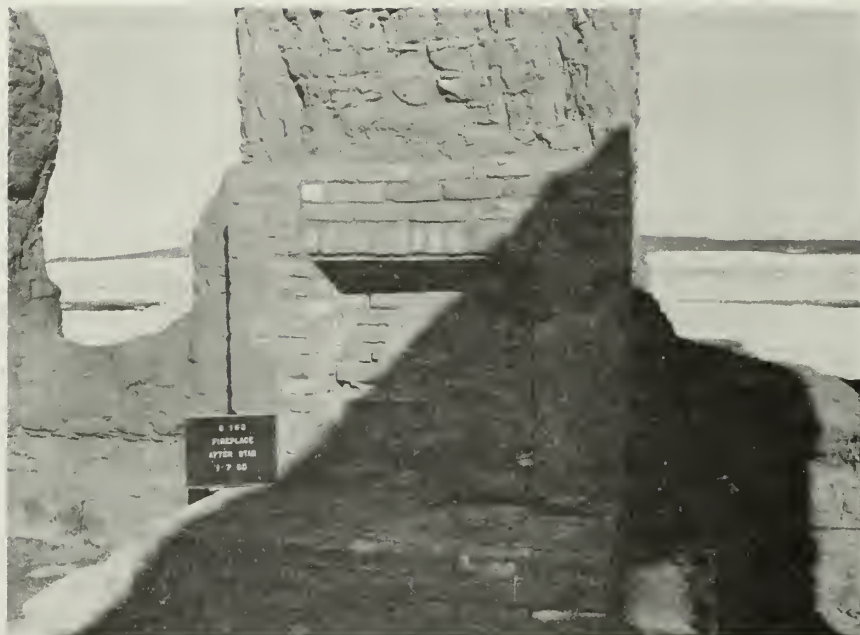
Details (notes on doorways, lintels, etc.): *Chimney and fire-place in east wall. North wall is south wall of rooms 161 and 162. Fireplace badly weakened by missing bricks. Loose bricks in chimney remnant. Brick hearth missing.*

FIGURE 93. Building 6-160, Room 163, fireplace in east wall, before stabilization. Fort Union National Monument.

FIGURE 94. Building 6-160, Room 163, fireplace in east wall, during stabilization. Historic bricks are being reset in soil-cement mortar. Fort Union National Monument.

FIGURE 95. Building 6-160, Room 163, fireplace in east wall, after stabilization. Soil-cement mortar used to reset bricks was brushed to prevent shine. Fort Union National Monument.

Materials, construction, and technique in making repairs or accomplishing job: *East wall: Missing foundation stones replaced in fireplace, brick hearth rebuilt with historic brick, missing fireplace brick reset in soil-cement mortar. Missing adobes were replaced in the north, east, and south sides of the flue. The small chimney remnant stabilized by resetting loose bricks in soil-cement mortar and replacing several missing bricks.*

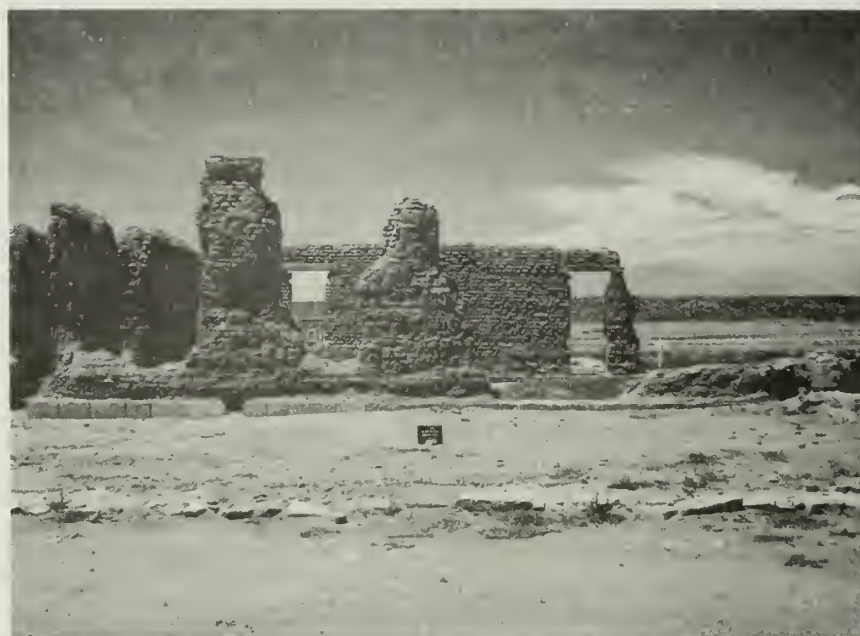
Condition on date work started. Masonry: *Nearly all of east wall missing except for flue. Many adobes missing from all sides of adobe flue. North wall in good condition. Lintels missing from window in south wall. West wall in good condition.*

FIGURE 96. Building 6-160, east side of east wall, before stabilization. Fort Union National Monument.

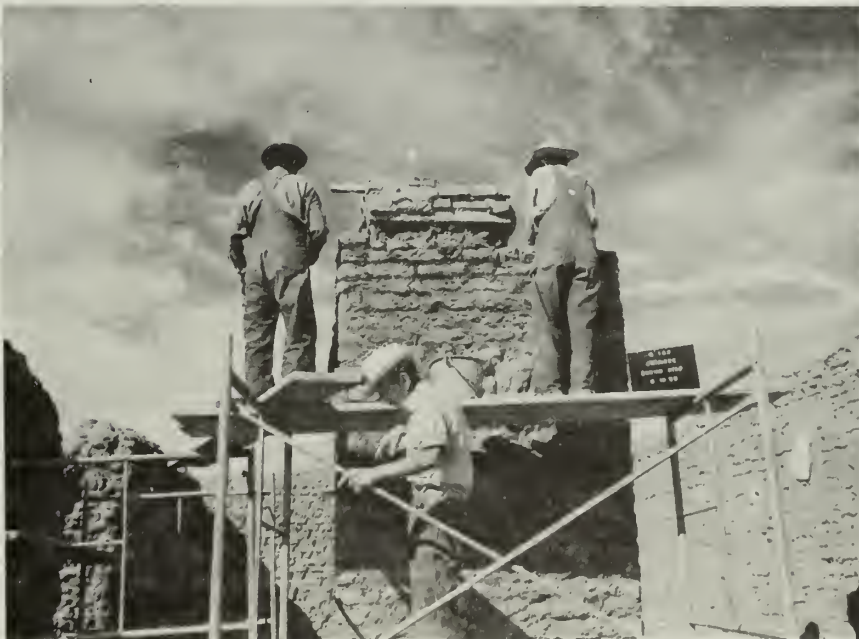
FIGURE 98. Building 6-160, Room 163, flue and chimney in east wall, during stabilization. Fort Union National Monument.

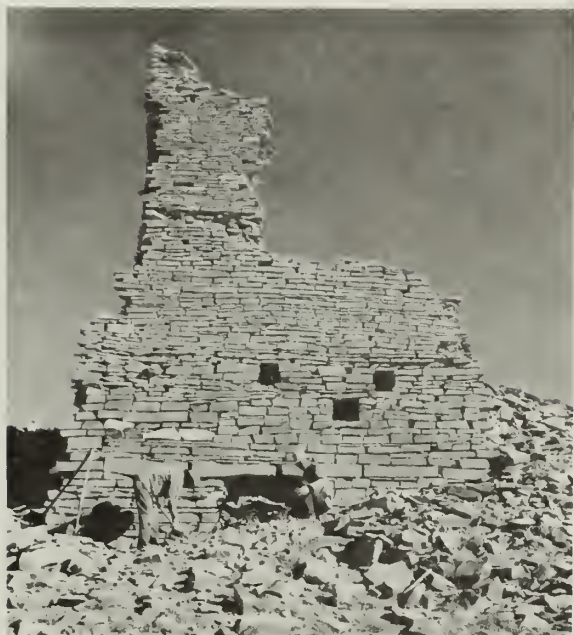
FIGURE 100. Close-up of north wall, Tower Kiva.

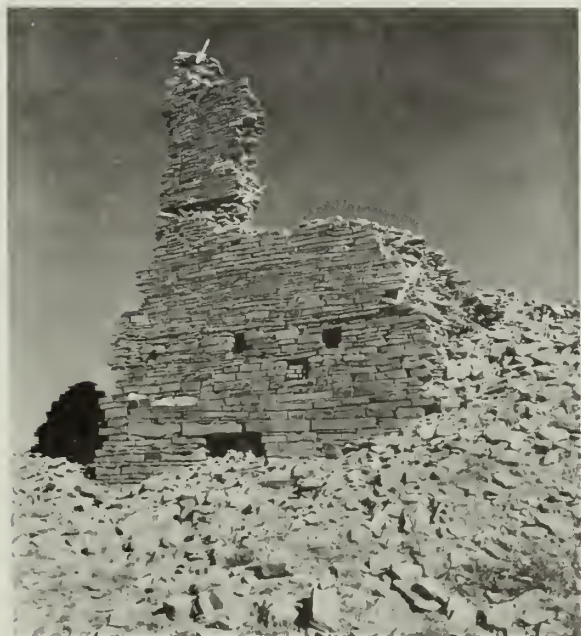
FIGURE 101. Tower Kiva, north wall exterior. Note large hole at base, and eroded insets (arrows) where second, third and fourth stories were slightly stepped back.

Considering its spectacular height, the wall is in good condition, but must be strengthened by repairing, reinforcing and capping to preserve its present condition.

Materials, construction, etc.: The Tower Kiva, north wall exterior. The high, sloping east and west wall stubs were capped, extending the east stub slightly eastward to provide a short but strong buttress section. Two integral members were placed in the west stub where it rises vertically, beginning at the second story level, the members extending to those rising from the east wall. The second and third story ledges or insets were repaired. The several openings including the two square beam holes, and the ventilator beneath them, and the beam holes at the east side were all repaired. The large hole at the base of the wall was filled with repair masonry in cement, the rough interior core being set in cement and the face stones laid in matching tinted cement. Following the above work, the entire wall face was grouted, pointed, and respalled. It was necessary to reset a few loose stones here and there in the facing.

The two eccentric, offset ledges along the north arc just above fill line were repaired. The lower half of a T-shaped ventilator in the center of the wall between the second and third story levels was repaired. East and west stubs were reinforced with paired integral members in connection with work on north wall exterior, already described. Within the upper kiva wall (includes the upper, spire-like fragment) considerable face stones were reset, and, where core was exposed, this was reset and pointed with soil-mortar. At the very top spire fragment itself, paired T-shaped integral members were installed.

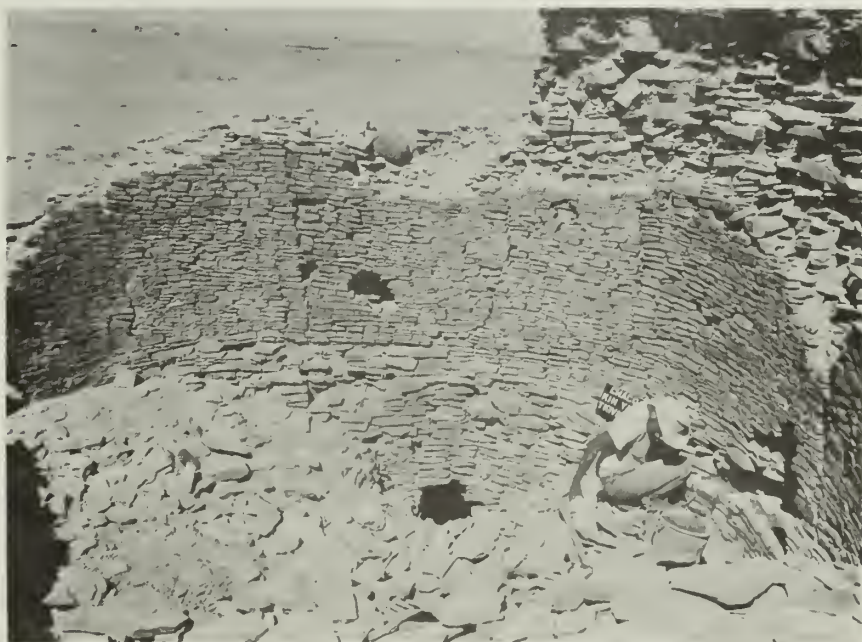
FIGURE 104. Another view showing general condition of lower part of interior.

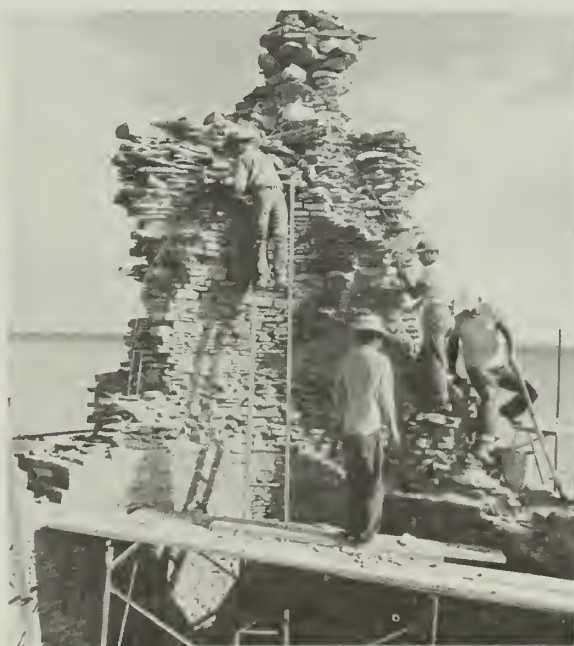
FIGURE 107. Tower Kiva, interior northeast corner, during installation of integral members to strengthen the highest wall section.

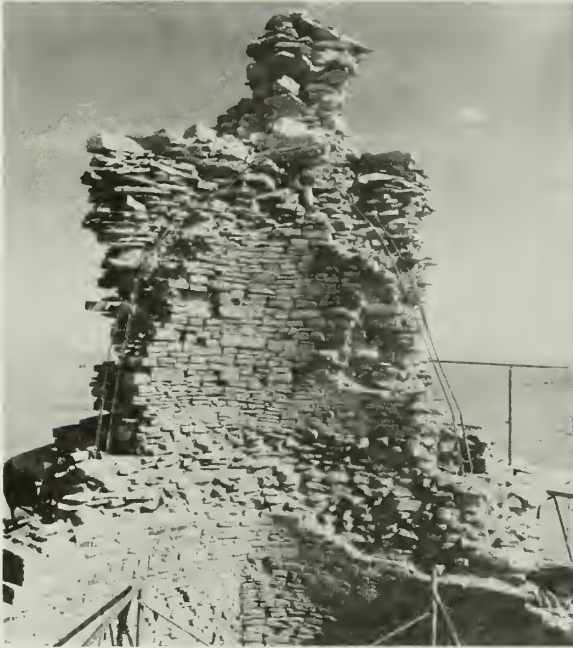
FIGURE 108. Upper portion of Tower Kiva, northeast corner interior, after the integral members were anchored in masonry.

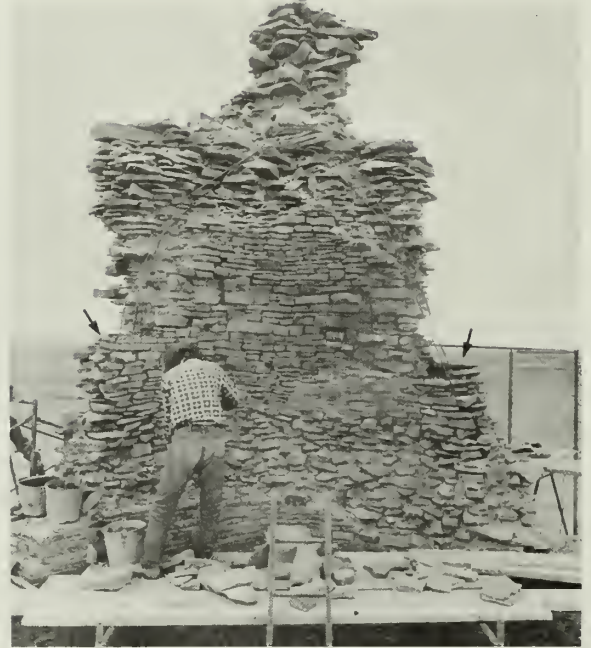
FIGURE 109. Beginning the vertical, reinforced capping (arrows).

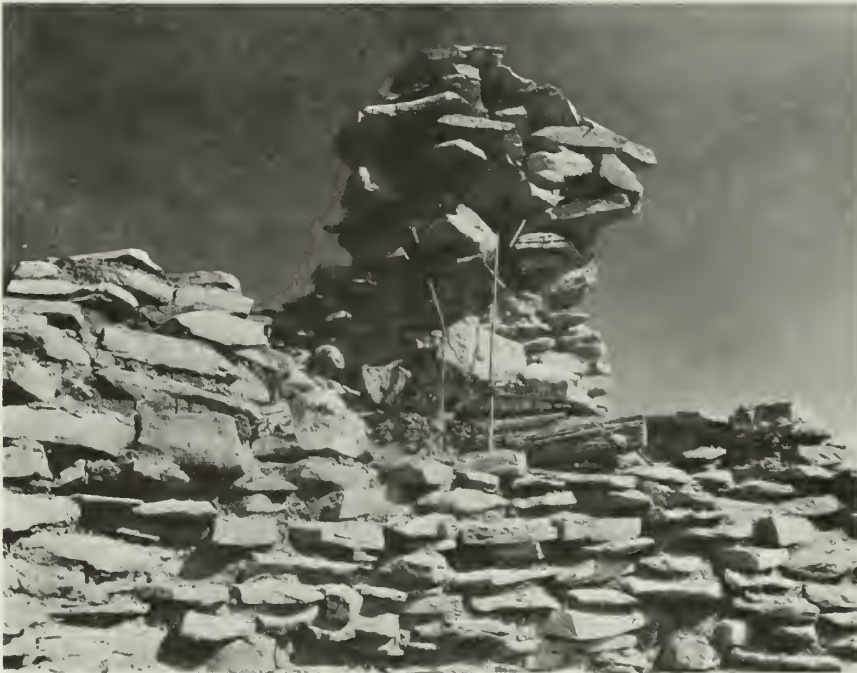
FIGURE 110. Integral members in the form of a T were installed in this top fragment of core masonry after the lower wall section had been strengthened to that point.

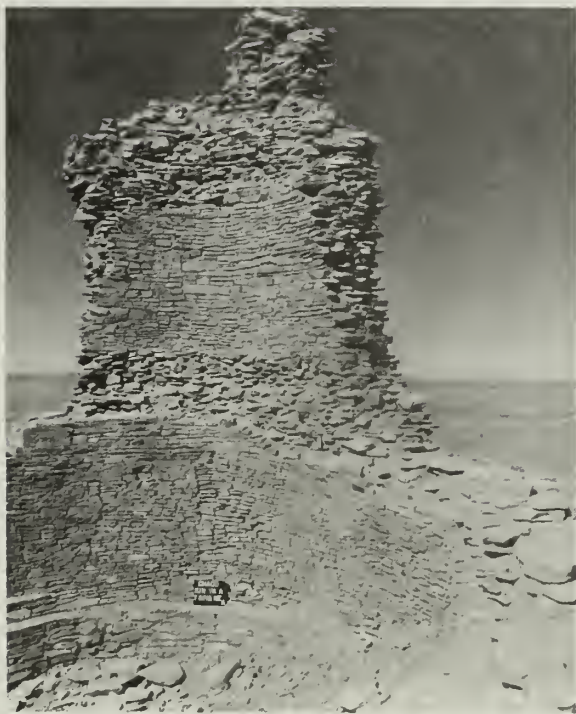
FIGURE 111. The wall at completion of stabilization. The wall is considerably strengthened and tightened, without a serious or objectionable alteration of the original profile.

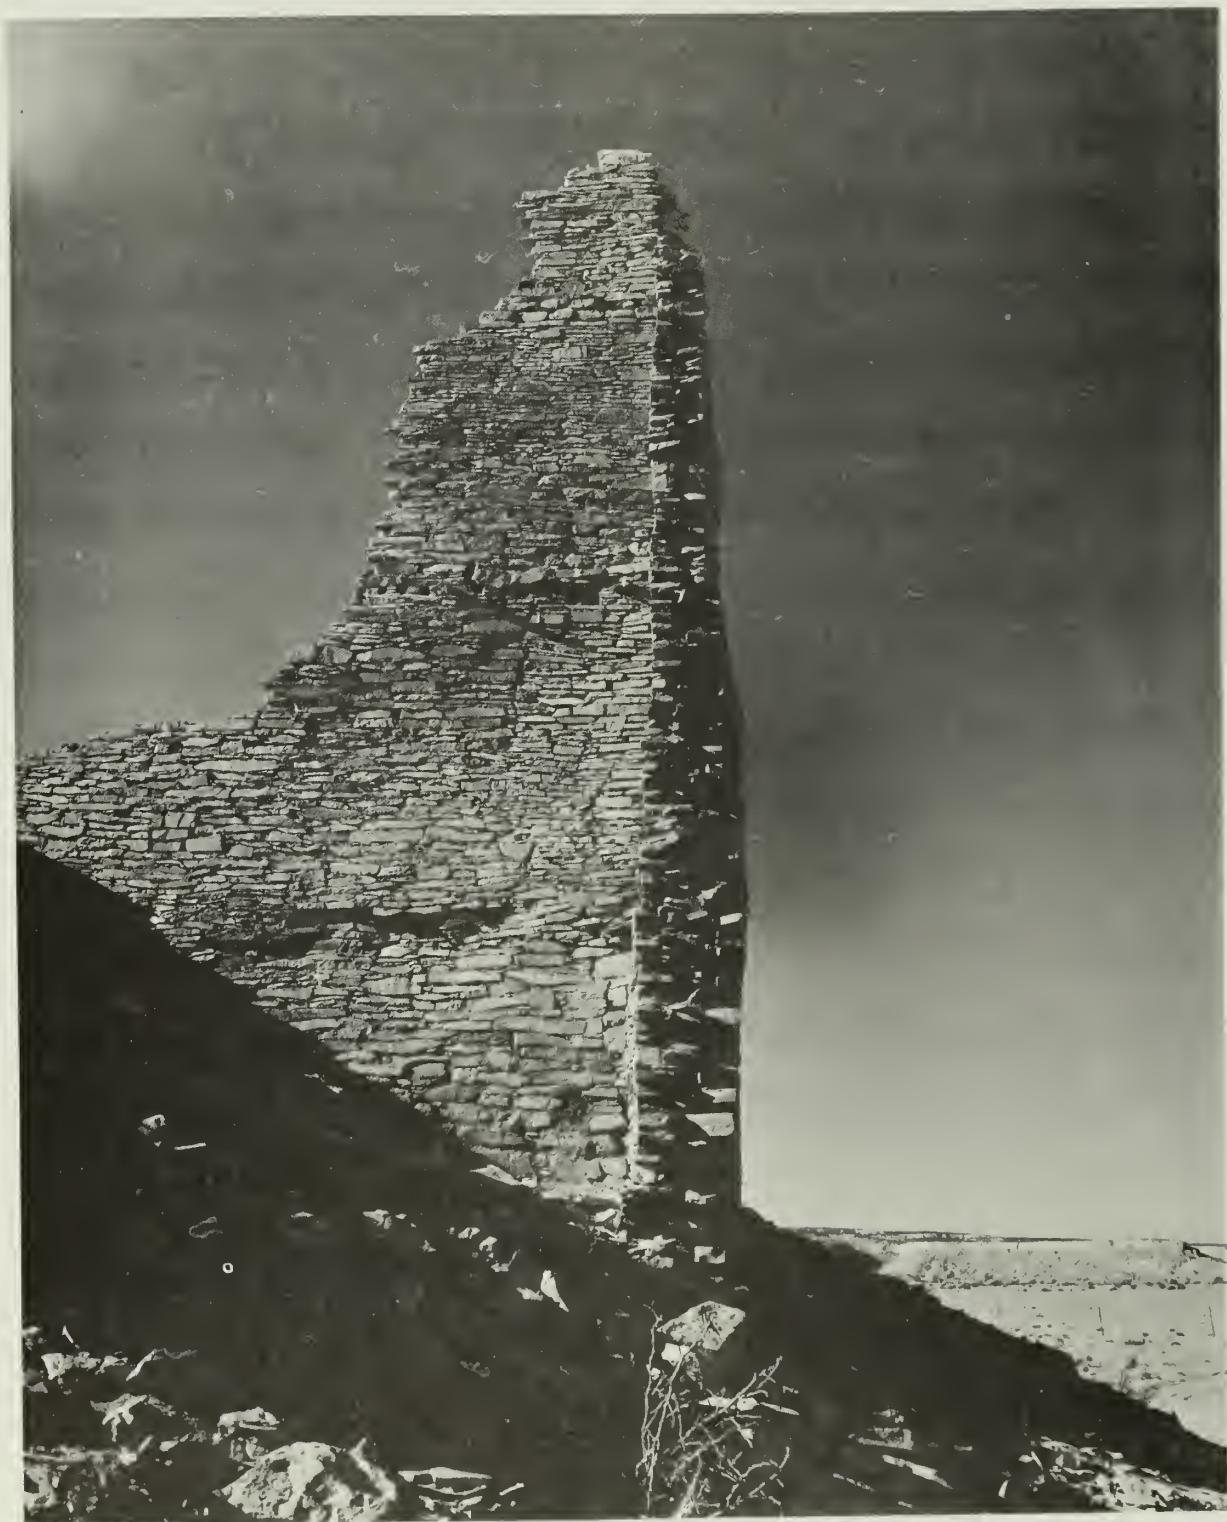
FIGURE 113. View of Tower Kiva showing vertical cap.

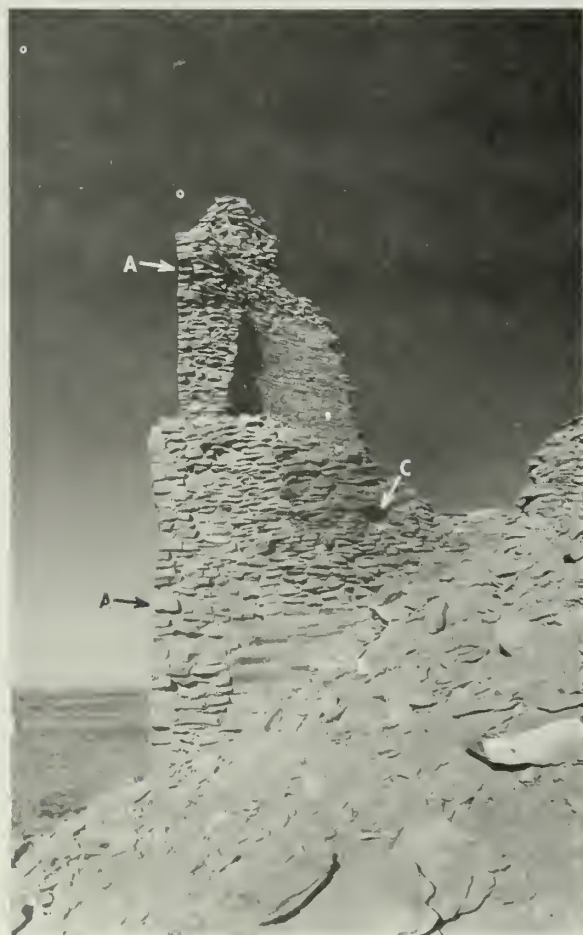
FIGURE 116. North wall stub capped (arrows A), lower portion of west wall facing reset (B), and exposed portion of thick core grouted (C).

Materials, construction, etc.: The Tower Kiva, west wall. Both northwest and southwest kiva corners were cleared of surface debris, and capped. The northwest outside corner was excavated until good foundation was encountered, and then the exterior facing was reset to a depth of 18 to 20 courses at the north end, and to a depth of 4 to 5 courses at the south end. The exposed core and veneer around the U-shaped opening in the central section was reset (figs. 115-117).

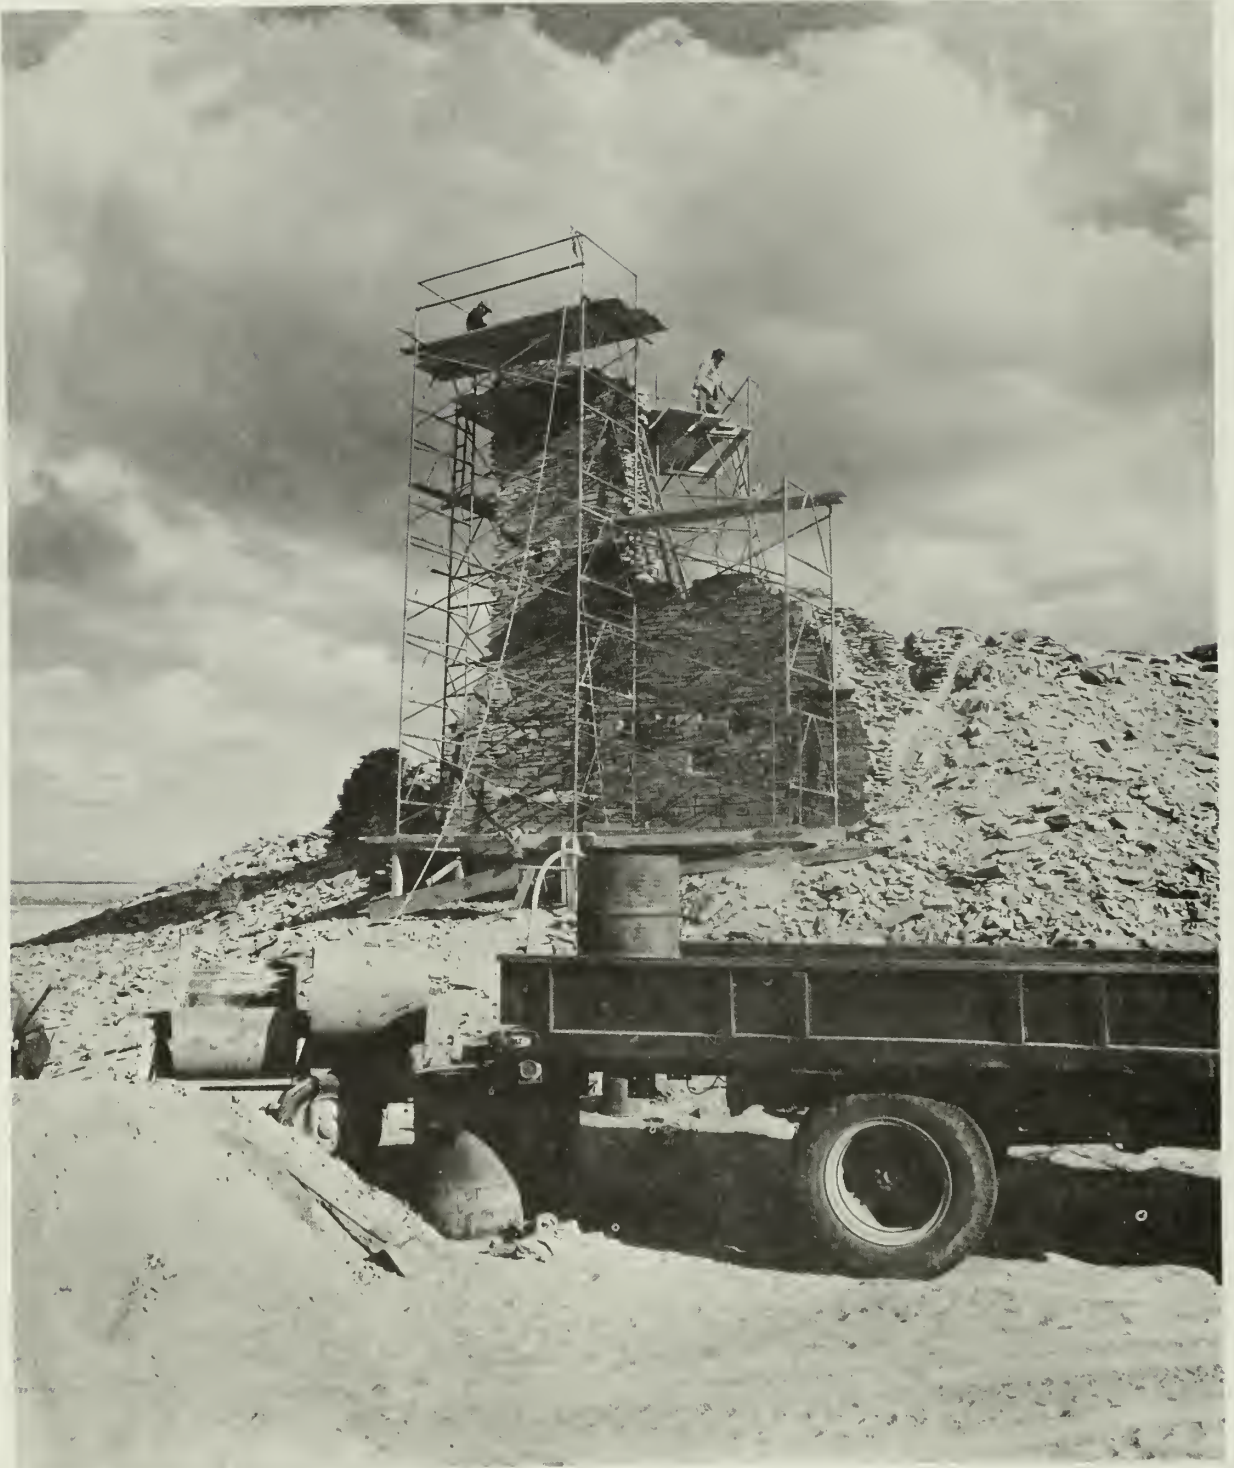
FIGURE 118. Work on the highest portion of the tower. The scaffolding completely surrounded the structure. To provide maximum safety for the workmen, the three sets of scaffolding were anchored at the bases and across the top and through midsections.

Figures 118 and 119 illustrate some work in progress on the Tower Kiva. Note the use and adaptability of tubular steel scaffolding.

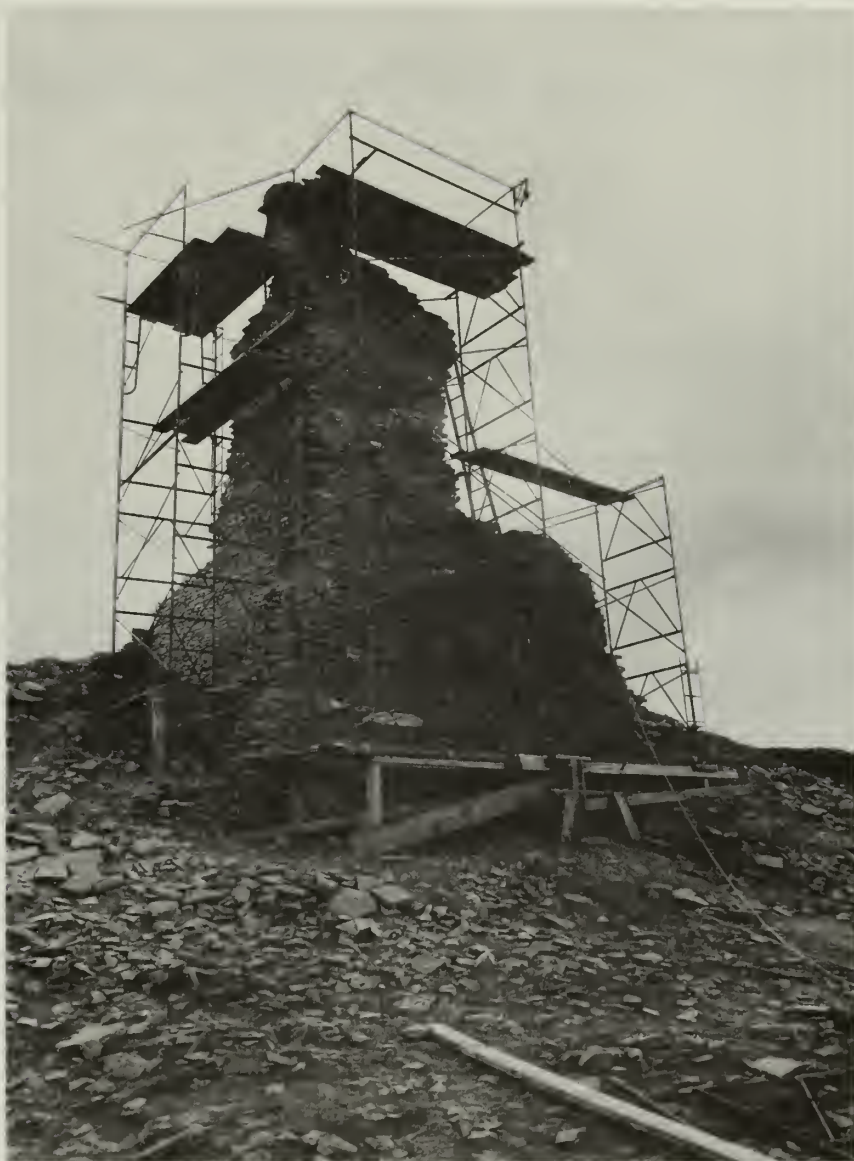
FIGURE 119. Tower Kiva. Scaffolding was anchored on firm and level bases built of heavy timbers.

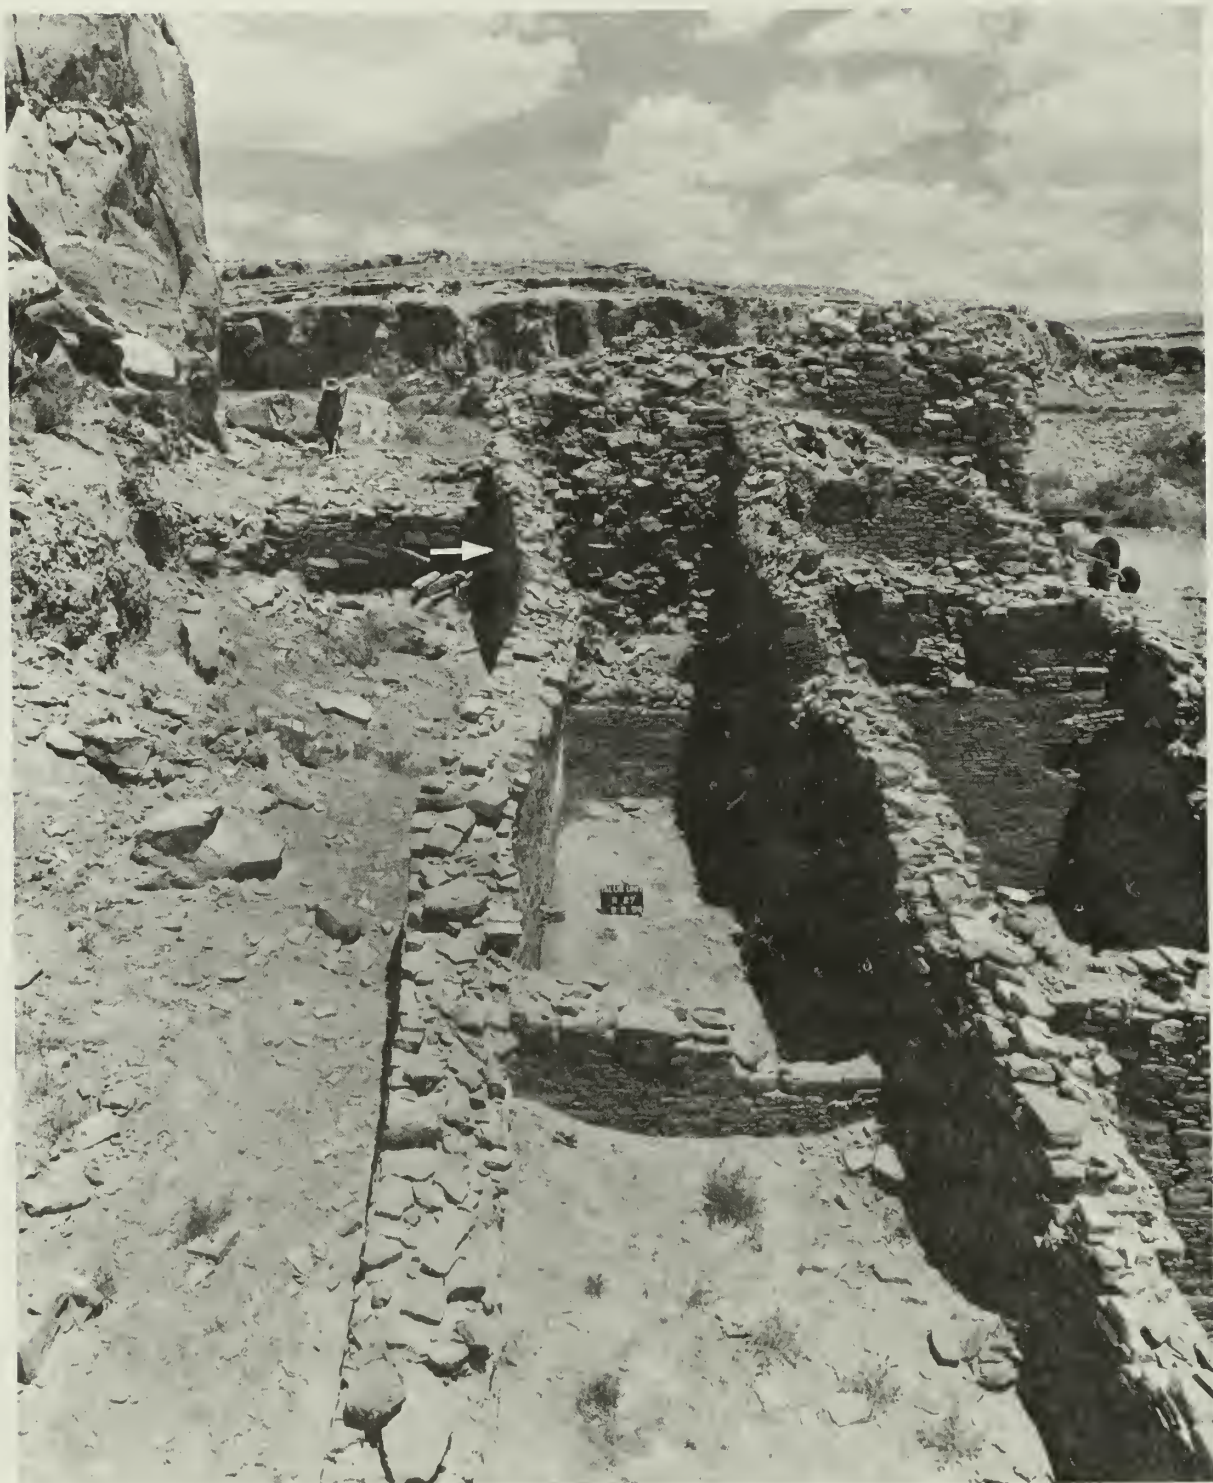
Ancient masonry: North wall above the ledge leans precariously into the room. East and west walls have eroded and are loose at the top. Footings of all four walls are undercut by erosion. Beam holes are eroding where beams have decayed.

FIGURE 120. The wall between Rooms 27 and 28, Talus Unit No. 1, was distorted and pushed out of line by pressure of fill, often damp, at left. Arrow shows direction of force. The purpose of the stabilization was to strengthen the wall against the pressure.

Materials, construction, and technique in making repairs or accomplishing job: *Part of the center section of the leaning wall was removed. A horizontal slab of steel-reinforced concrete was poured so as to abut against the junction on the partition walls. Steel rods were fastened through both wall and slab with turnbuckles between. Using the turnbuckles, the wall was pulled back to nearly vertical position. The stones removed were then replaced in tinted cement. East and west walls had already been patched and strongly capped to bear the load. New stones were set in cement around the wall footings. The beam holes were patched in tinted cement.*

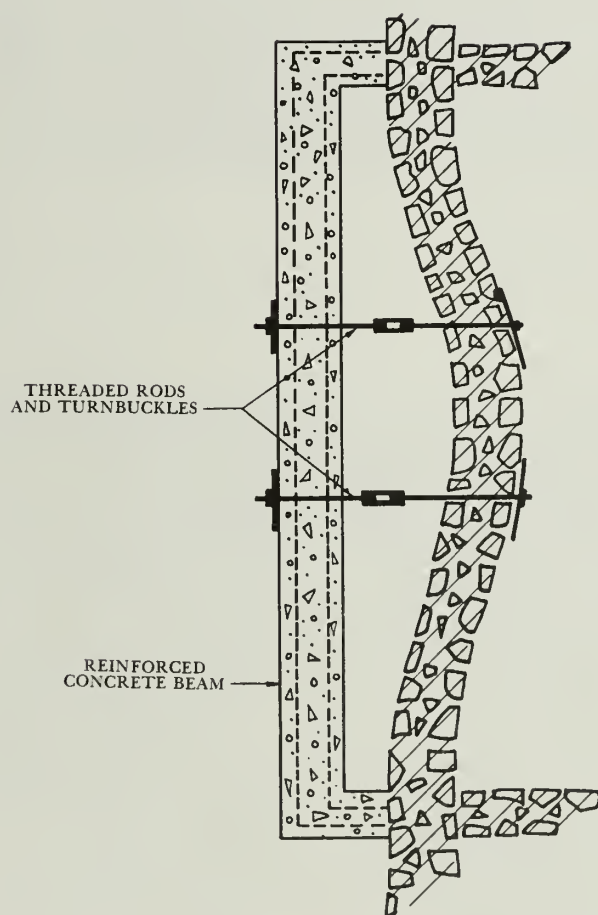
FIGURE 121. Plan of reinforced beam to realign and hold north wall, Room 27, Talus Unit No. 1 (not to scale).

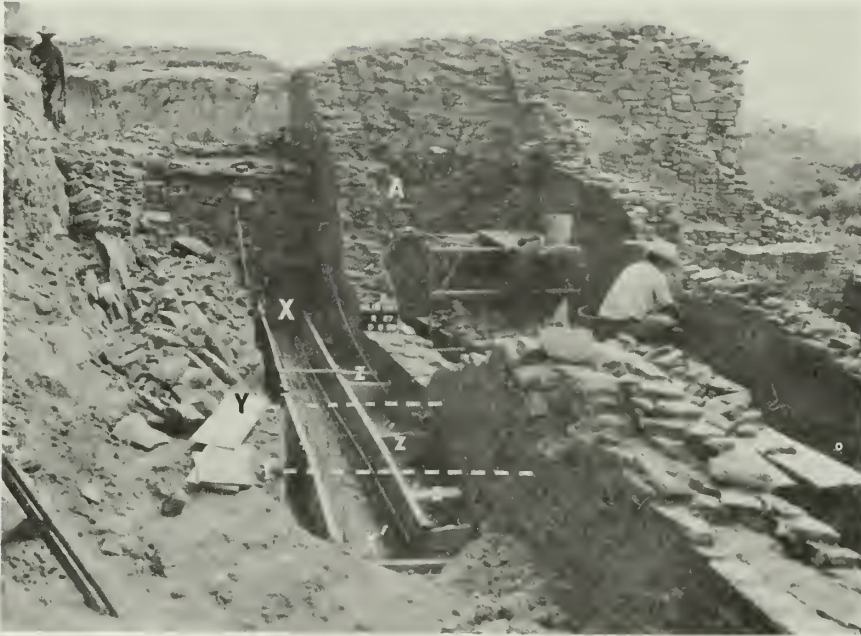
FIGURE 122. Construction of concrete beam shown in figure 121. The frame is complete and reinforcing rods are in place. X—X1- beam, Y—location of threaded rods and turnbuckles, Z—temporary braces. The ends of the beam bear against the wall at each side of the bulged area at points where the wall is braced against movement by partition walls. That at the east shown as A.

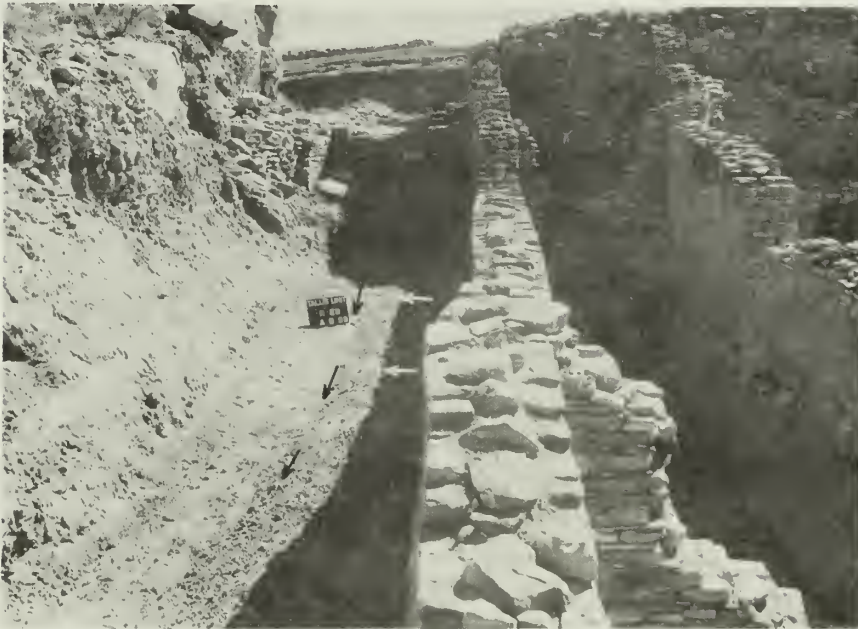
FIGURE 123. This wall in Talus Unit No. 1 has been pulled back into line; the capping is straightened up. The concrete beam dug into Room 28 is covered and the surface of this room (arrows) is graded to carry surface runoff away from the damaged wall.

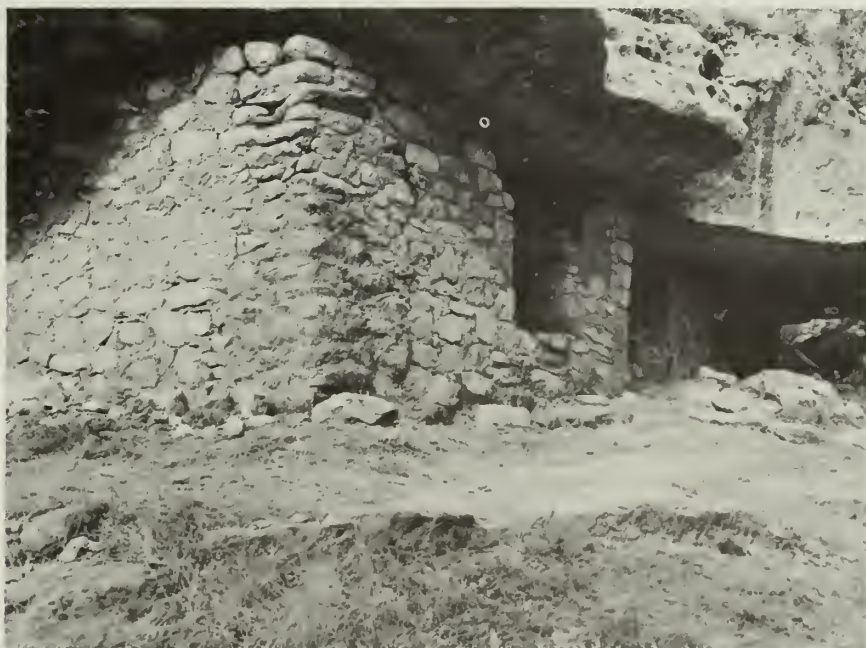
FIGURE 126. Room 1, east exposure, after replacement of fallen corner. The deeply eroded wall base was grouted, and the area above the doorway was partially reset. (Walnut Canyon National Monument)

Materials, construction, and technique in making repairs or accomplishing job: *North Wall: The large hole measuring 3' x 4' was filled with repair masonry to save the upper section, and the northeast corner was buttressed also to preserve it. Repair work stained with black mortar color to match original.*

East Wall: Entire foundation one stone high was grouted and pointed. The south wall also had a few small holes along the foundation row where original soil-mortar had eroded and these were filled. Sill and wall area below door grouted and pointed.
